Oxygen Regulator Flash Severely Burns One Fire Fighter - Florida

SUMMARY

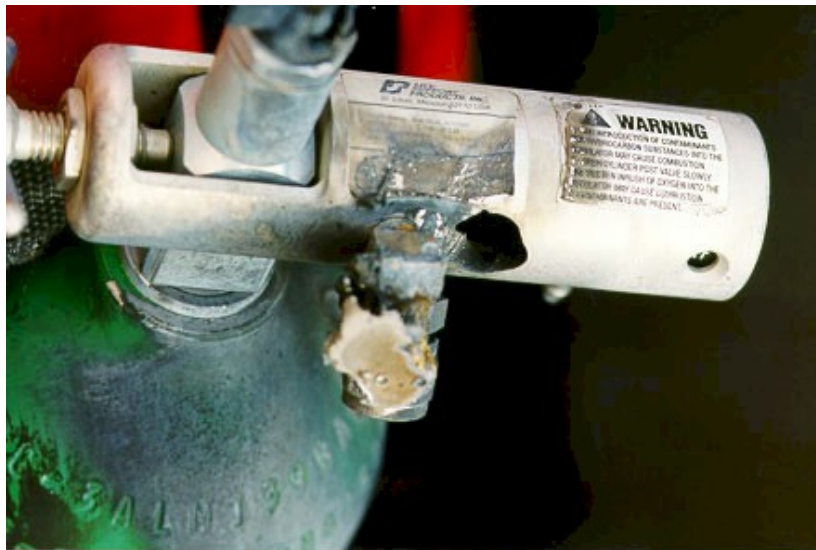
In addition to the replacement parts, the retrofit kit contained a warning sticker that was to be placed on each regulator as soon as it had been retrofitted (Photo 6). The sticker read: *WARNING: 1. The introduction of contaminates and hydrocarbon substances into the regulator may cause combustion; 2. Open the cylinder post valve slowly. The sudden inrush of oxygen into the regulator may cause combustion if contaminates are present.* The sticker served not only as a warning but also as an identifier to indicate regulators that had been retrofitted. A retrofit sticker had been placed on the regulator involved in this incident. After the incident, the fire department sent the cylinder and regulator involved in the incident to an independent testing laboratory for further testing.

Photo 6: This photo depicts the warning label that is placed on the retrofitted regulator. The sticker serves as a warning as well as an identifier that the regulator has been retrofitted.
