Subject: **Oxygen Fueled Fires :
December 2007 Update**

SAFETY ALERT

12/2007 – Winter

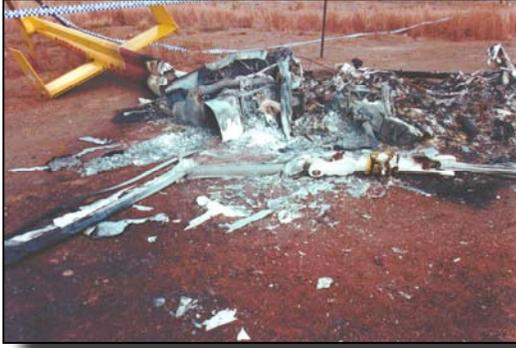
In searching for additional data on this problem I also became aware of a 1997 medical oxygen related fire in a Bell 206-L3 helicopter on the ground in Australia. Although the cause of this particular fire differs dramatically from the issues discussed in this alert, the picture of the totally obliterated, charred hulk was most sobering. I have used this photo for shock value and to try to get rid of the complacency I have encountered with the reluctance to spend \$25 to safeguard against a fire in a multi-million dollar aircraft.

An oxygen fueled fire in a small or medium helicopter would be devastating as illustrated and may be impossible to extinguish in flight due to the oxygen enriched atmosphere that would likely be present.
